# **In-Service Evaluation of HVOF Coated Main Landing Gear on Navy P-3 Aircraft**

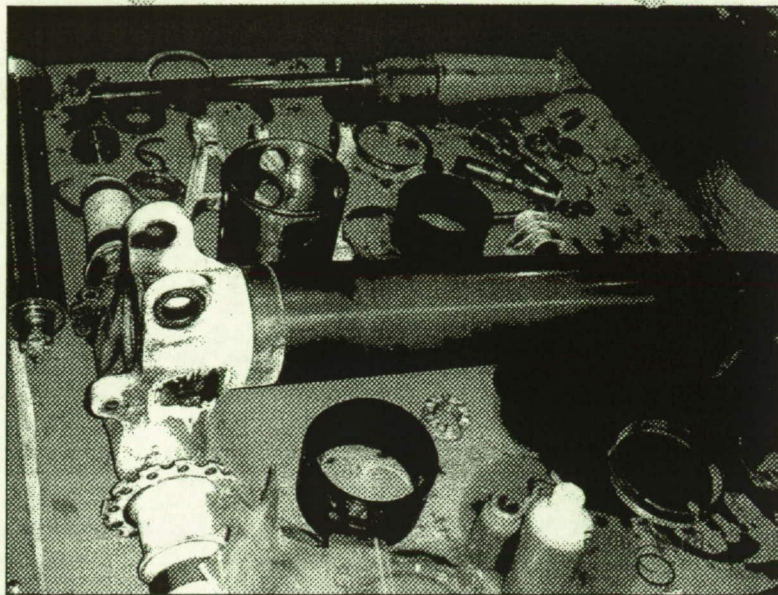
The P-3 R/H MLG shock strut assembly was examined in the as-received condition. The strut showed no visible signs of leakage, damage or other issues that would have forced it off the aircraft for cause. Figure 1 shows the disassembled strut assembly.

**Figure 1. P-3 MLG Shock Strut Disassembled**

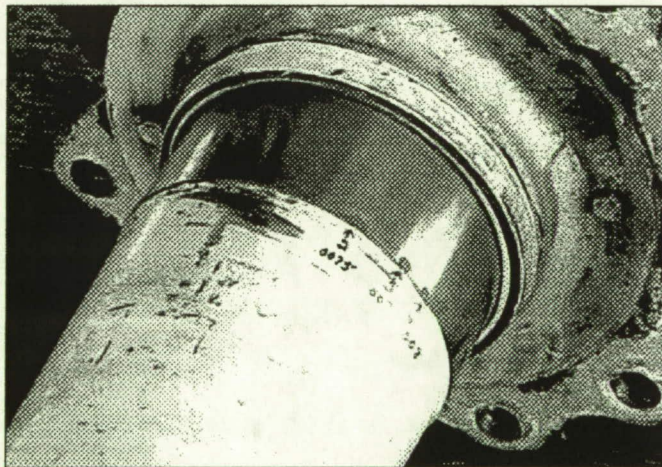
The service evaluation was an excellent test for a known problem of coating chipping/flaking at the edge of the axle wheel bearing journals. Typically EHC on axle journals of military aircraft is chipped as shown in Figure 2 when the brake assembly is installed and dragged across the axle journals without the use of a brake dolly.

**Figure 2. Typical Brake Install Chrome Damage on Axle Journals**

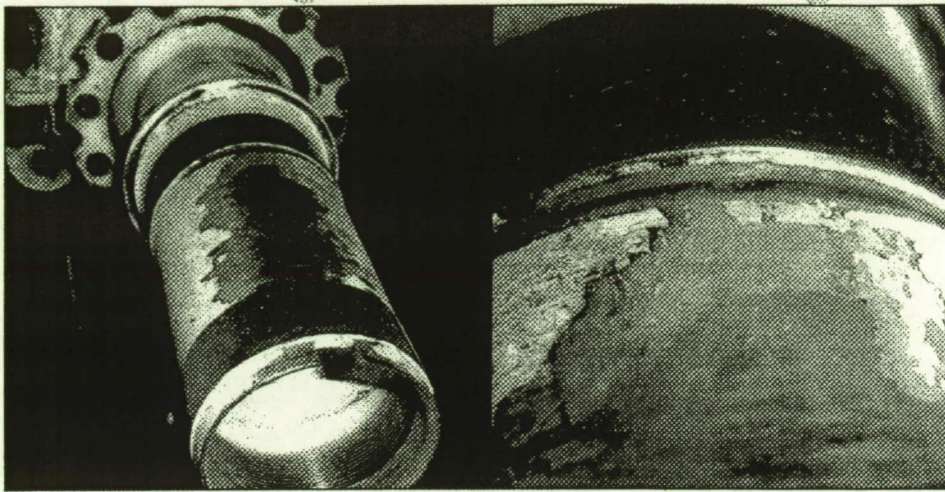
The HVOF axle journal inspection indicated the brakes had been repeatedly dragged over the journal edges as evidenced by the damaged paint on the top of the axle surface shown below in Figure 3.

**Figure 3. HVOF Piston Axle Brake Install Damage Between Axle Journals**

The four HVOF coated axle journals were all in very good condition and still showed staining evidence from the plastic mesh used to protect the axles during original processing indicating essentially no wear to the HVOF surface. There was no chipping of the HVOF coating edges (as typically seen with chrome plating).

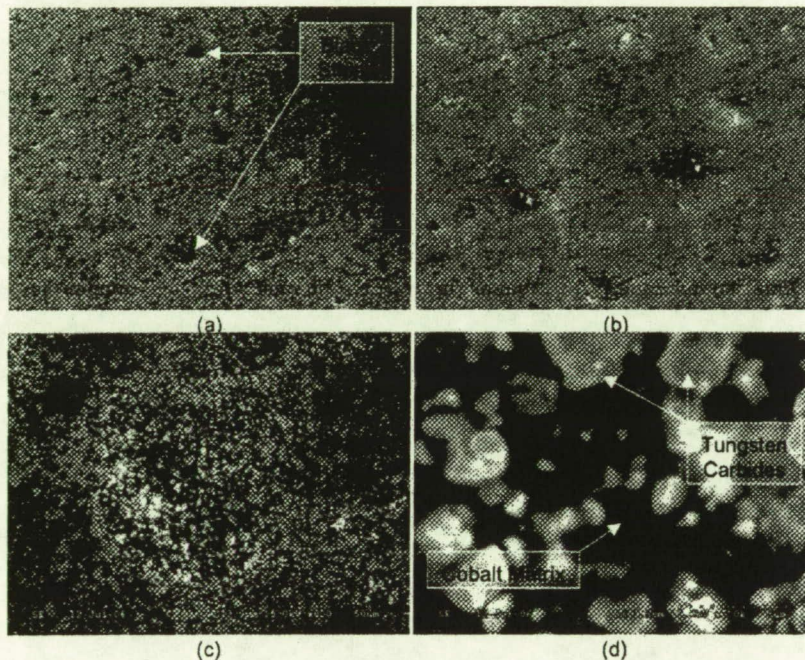
Visual and surface roughness inspection revealed the lower portion of the shock strut barrel had degraded from its original condition. This degradation was observed as "black spots" on the surface as shown in Figure 4. Due to the fact the piston had to be condemned for exceeding the minimum wall thickness requirement due to corrosion (not related to the HVOF coated surfaces), the piston was available for destructive microscopic analysis. Three separate coupons were sectioned from each area of the piston for microscopic analysis using a Scanning Electron Microscope (SEM) with Energy Dispersive Spectroscopy (EDS). SEM analysis revealed that the "black spots" were shallow pits, containing corrosion byproducts, shown below in Figure 4. Elements detected by EDS in the pitted areas included Cl, K, Ca, and Na, indicating that the pitting was likely the result of seawater environmental attack of the cobalt matrix.

**Figure 4. Secondary Electron Images of Black Spots (Pits) on Piston Barrel Lower Environmentally Exposed Surface: (a) x40, (b) x120, (c) x800 and (d) x7000**

Metallographic analysis of polished cross sections indicated that the worst pits were approximately 0.001 inches in depth and 0.010 inches in diameter, which is considered larger and deeper than average porosity of the HVOF coating surface.

Although the piston was condemned for another reason, it is believed the barrel section could have been superfinished to remove black spot pitting and phenolic bearing material transfer, restoring all the dimensional and surface roughness requirements and returned to service for another maintenance cycle.
